ALLEGHENY  
COUNTY AIRPORT

# Environmental Assessment for the Runway 10-28 Runway Safety Area Improvement Project

August 2022

Prepared by:  
Environmental Science Associates  
550 Kearny St, Suite 800  
San Francisco, CA 94108

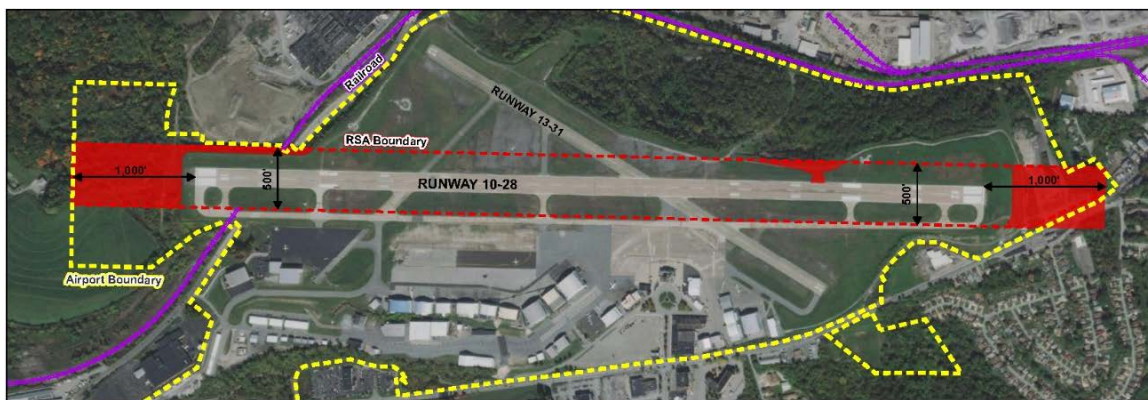
**Figure 1-3**  
Runway 10-28 Standard RSA Deficit (red)

For Runway 10-28, a standard RSA would extend 1,000 feet from the departure end of the runway, be 500 feet wide, and have no more than 3 percent slope for 200 feet off the runway end and at maximum 5 percent thereafter (**Figure 1-3**).<sup>10</sup> However, a standard RSA for Runway 10-28 at AGC is not feasible. The RSA has been determined by previous studies and airport master plans to be 1,000 feet short on the Runway 10 (western) end and 793 feet short on the Runway 28 (eastern) end, and, in some areas, steeper than the FAA standards. The area off the Runway 10 end has an

approximately 20 percent slope, and the area off the Runway 28 end has a 7.6 percent slope. There is also development around the runway within the dimensions of a standard RSA that cannot be reasonably relocated, such as the highways, railroad, landfill, and residential developments. Both the Railroad and State Highway 885 run through a tunnel underneath the Runway 10 end and Lebanon Church Road runs at grade through the RSA beyond the Runway 28 end.

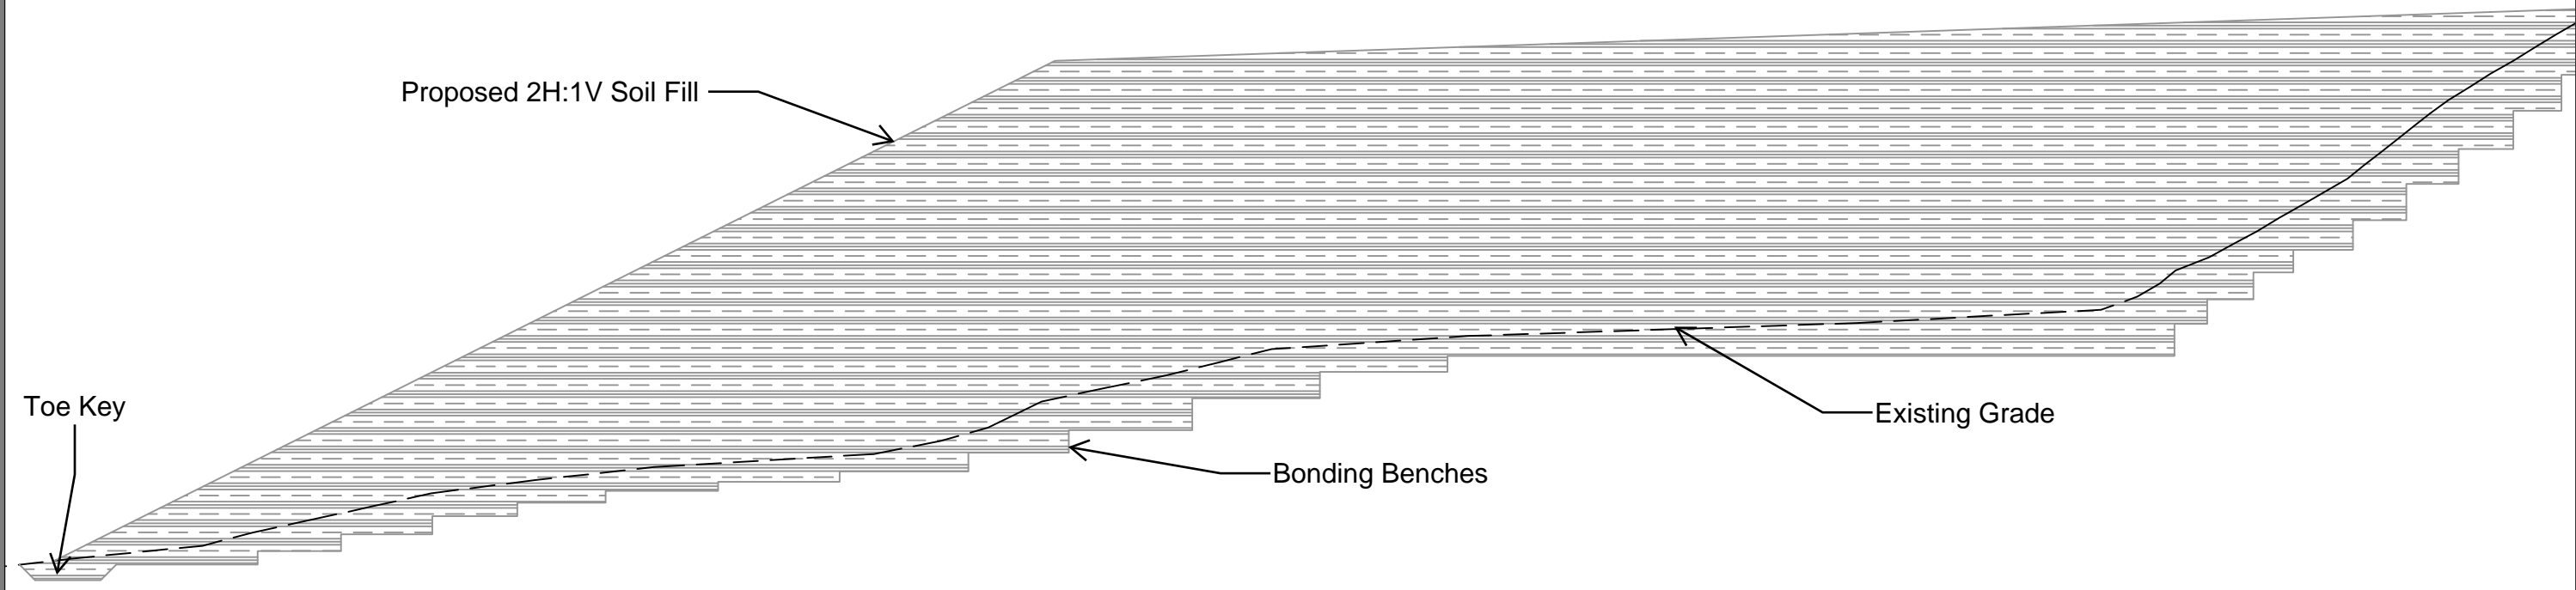
FIGURE 8 - 2H:1V Fill Slope Conceptual Sketch

Typical Toe Key  
(Drainage Not Shown)

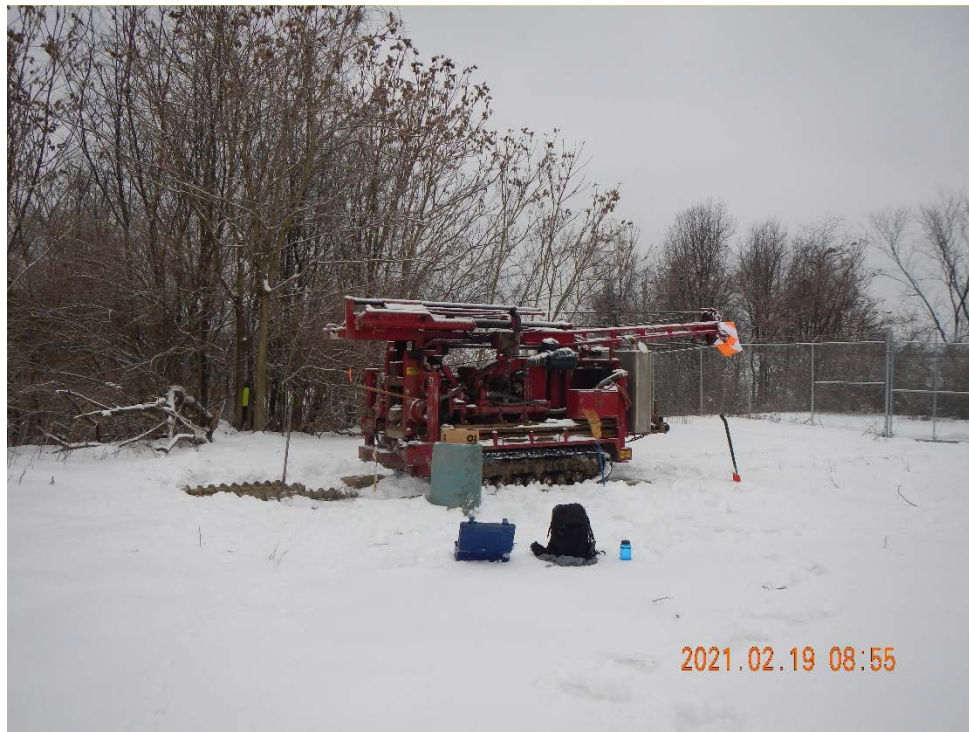
**Photograph 1. Looking southwest at Boring B-6.**

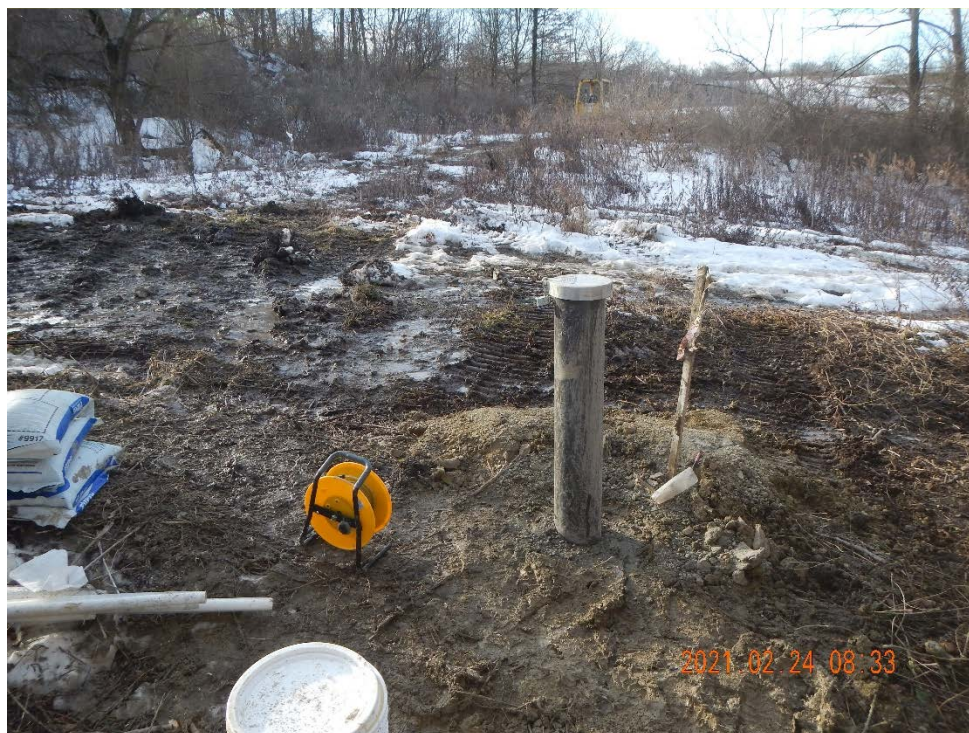
**Photograph 2. Looking south at monitoring well installation at Boring B-5.**

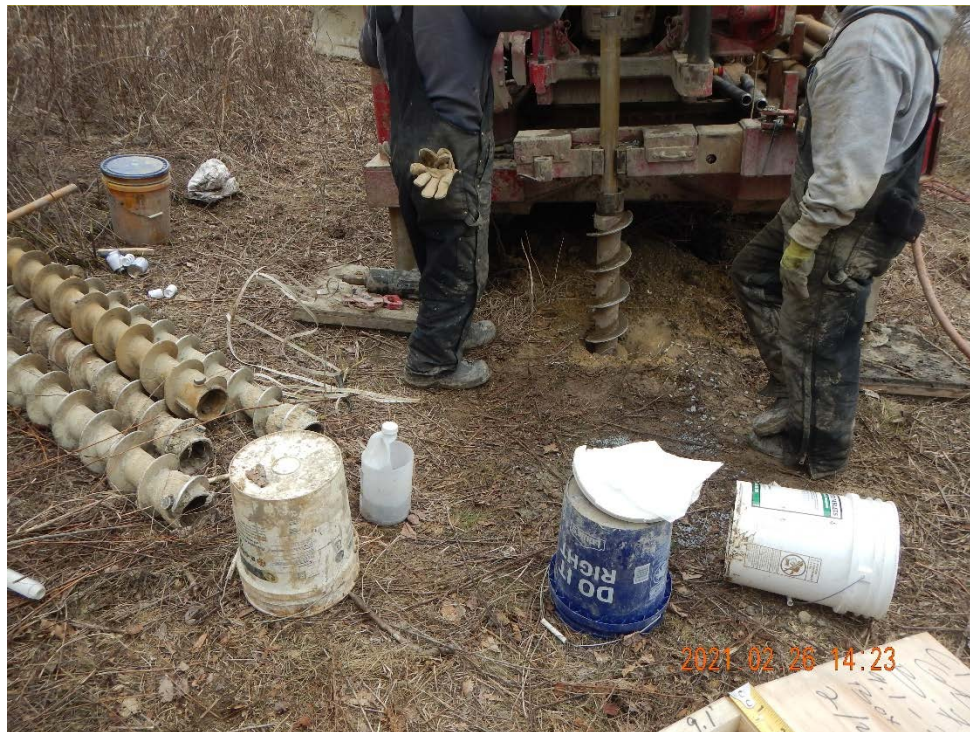
**Photograph 3. Looking south at Boring B-7.**

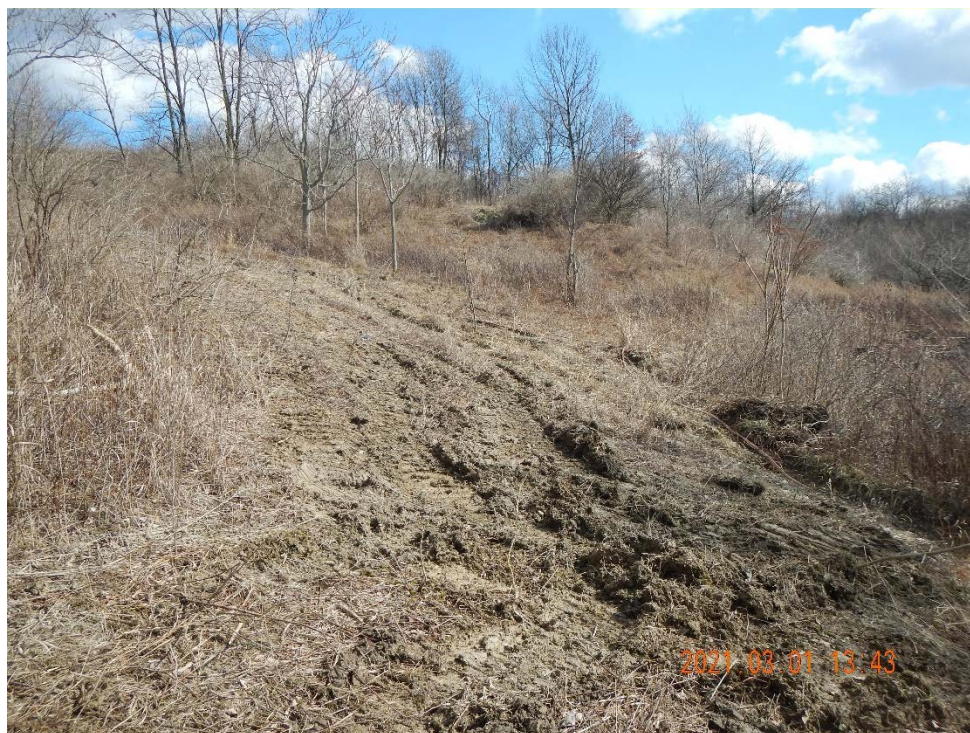
**Photograph 4. Looking south at dozer clearing near Boring B-7.**

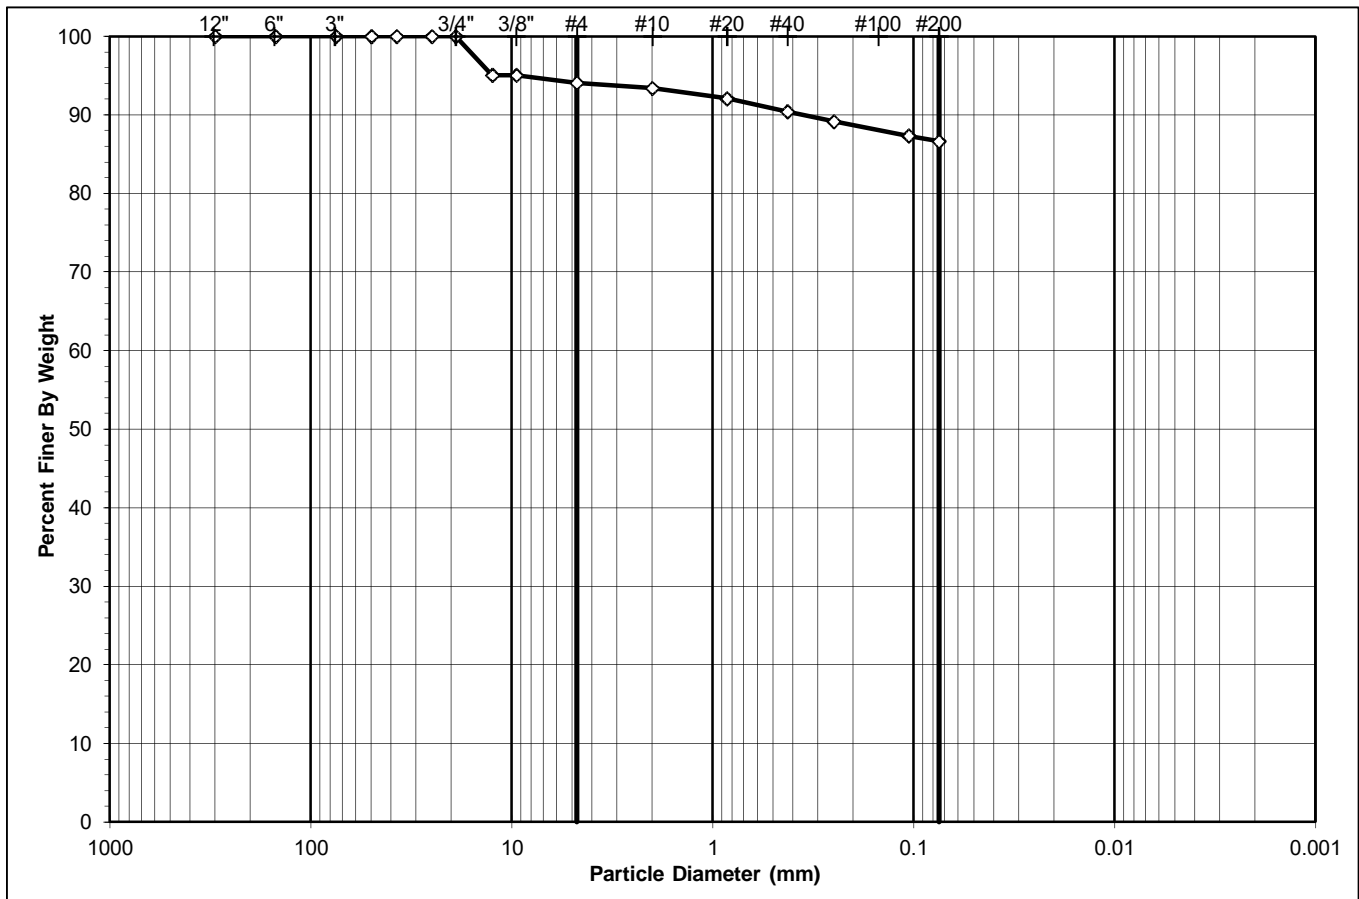
USCS Summary		
Sieve Size (mm)		Percentage (%)
Greater Than #4	Gravel	5.92
#4 to #200	Sand	7.45
Finer Than #200	Silt & Clay	86.63
<b>USCS Symbol:</b> <b>CL, TESTED</b>		
<b>USCS Classification:</b> <b>LEAN CLAY</b>

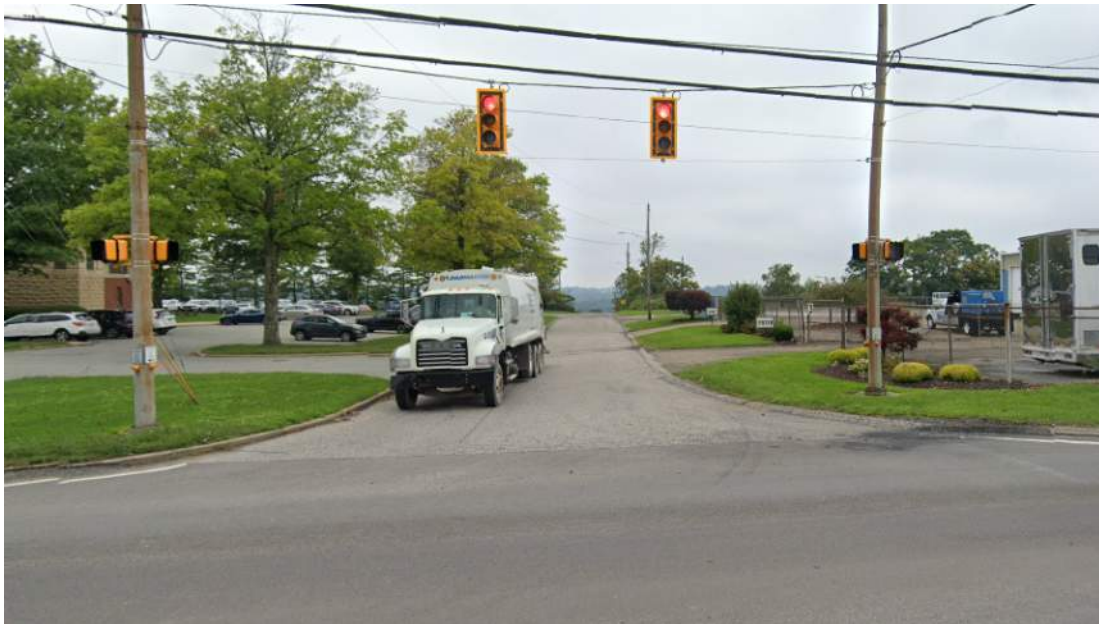
A potential access point for vehicles to reach the western end of Runway 10 is through the US Steel property at the western end of Noble Dr. Noble Dr's intersection with SR 0885 (Lebanon Rd) is signalized and opposite a bus garage, so larger vehicles frequently use this intersection.

Looking Towards Noble Drive from SR 0885 (Lebanon Rd)

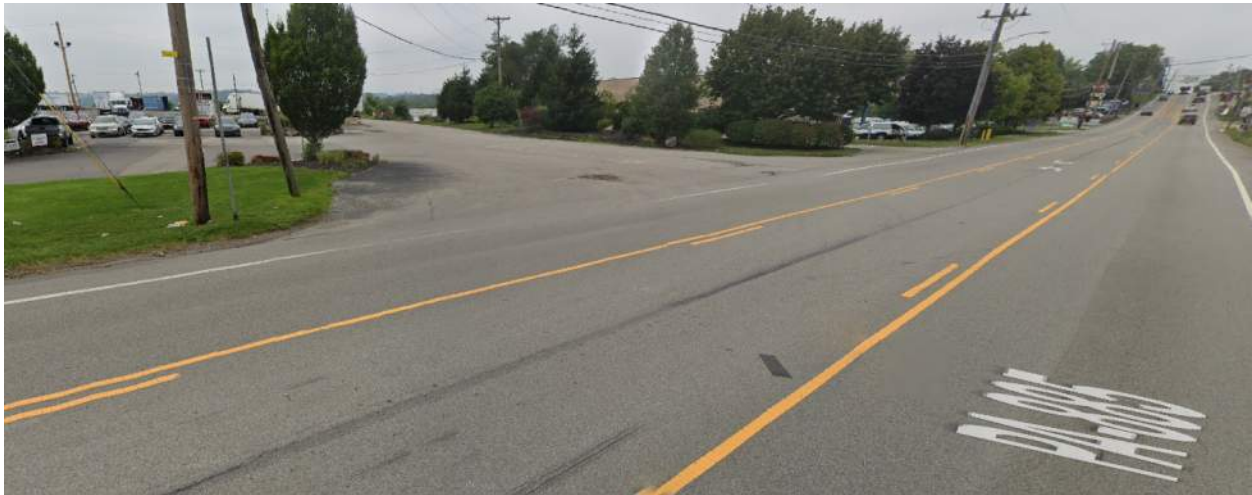
A potential access point for vehicles to reach the western end of Runway 10 is through the South Hills Industrial Park (SHIP). The facility functions as a distribution center and truck driving school, so the driveway currently experiences truck use. As such, no driveway improvements are assumed:

Driveway Entrance from SR 0885

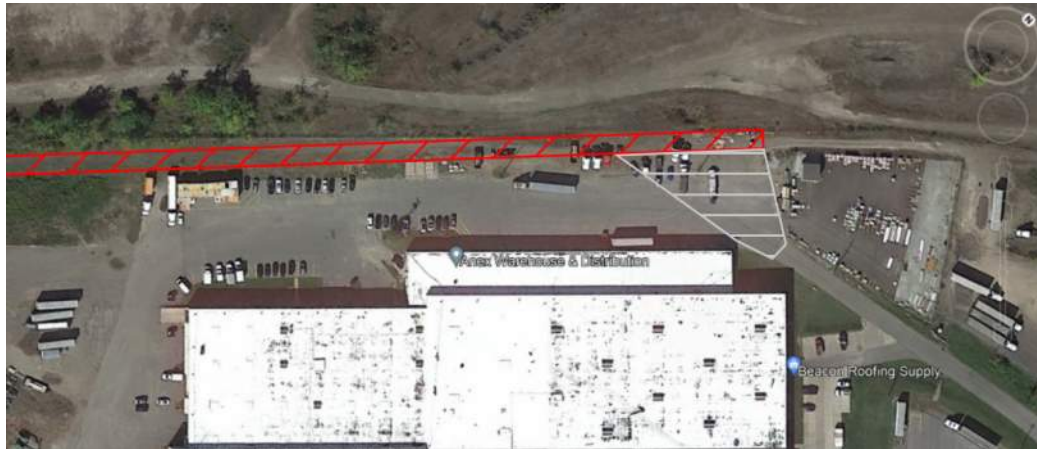
traffic would not conflict with the site, to limiting hours of through truck traffic, to building a haul road in the back of the site as shown:

Potential Haul Road (Red Hatch) and Lot Improvements/Restrictions (Gray Hatch)

Compared to extending Noble Dr, using the SHIP Driveway is not preferred as a suitable connection to SR 0885. Ultimately the final determination will be based on agreements with private property owners, though this access point is not under consideration at this time.

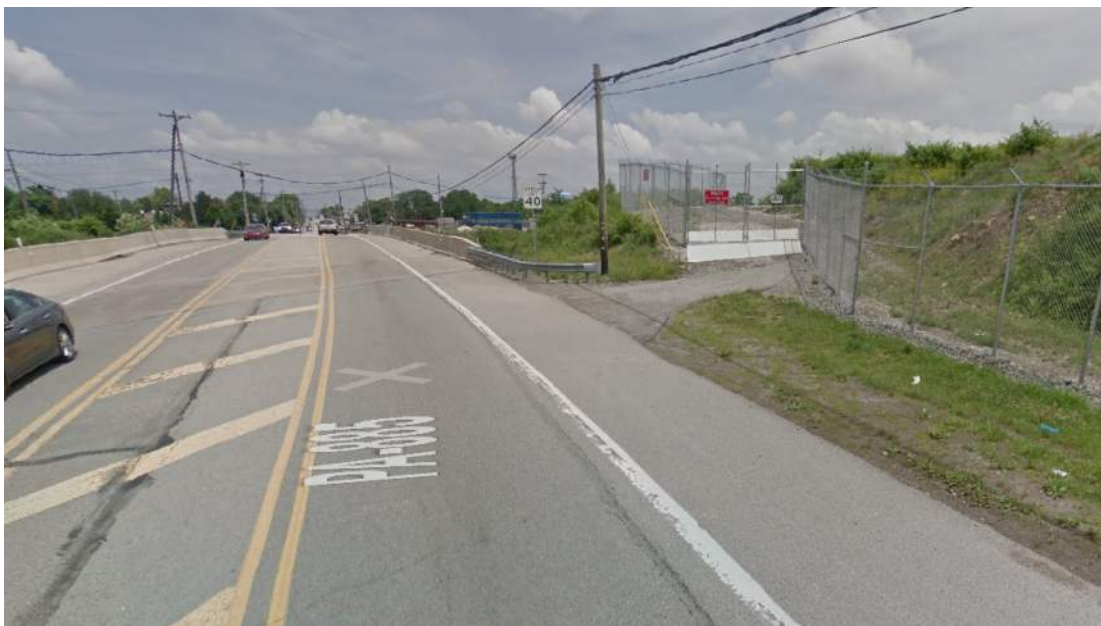
A potential access point for vehicles to reach the western end or midfield area of Runway 10/28 is through the existing airfield gate at the western end of Runway 13.

Airfield Driveway Entrance from SR 0885

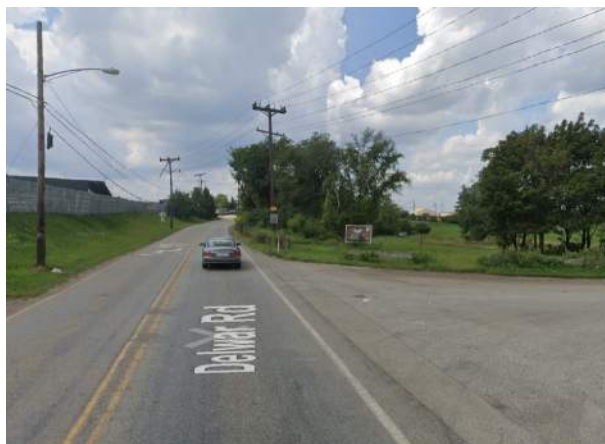
A potential access point for vehicles to reach to western end of Runway 10 is through the existing US Steel property and driveway along SR 2047 (Delwar Rd). To the southeast of the driveway, there is a sharp curve with an overhead Union Railroad bridge. Based on a site visit, there appears to be sufficient clearance for triaxle trucks to proceed under the bridge without incident.

Looking East from US Steel Driveway

The existing US Steel Driveway location has limited stopping sight distance, which creates borderline conditions for safe turning movements. Vegetation trimming and additional signage and pavement markings could help improve sight distance conflicts using this driveway location.

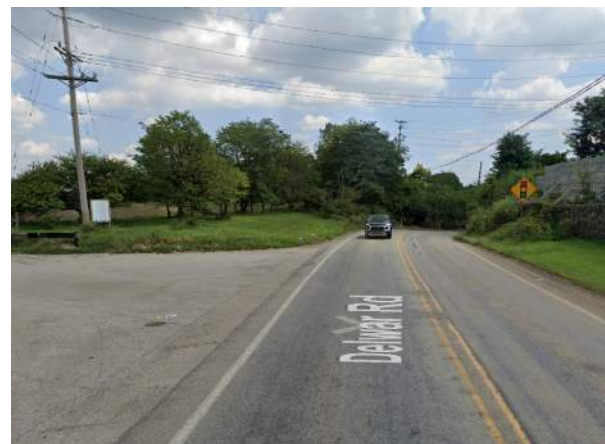
Looking West from US Steel Driveway

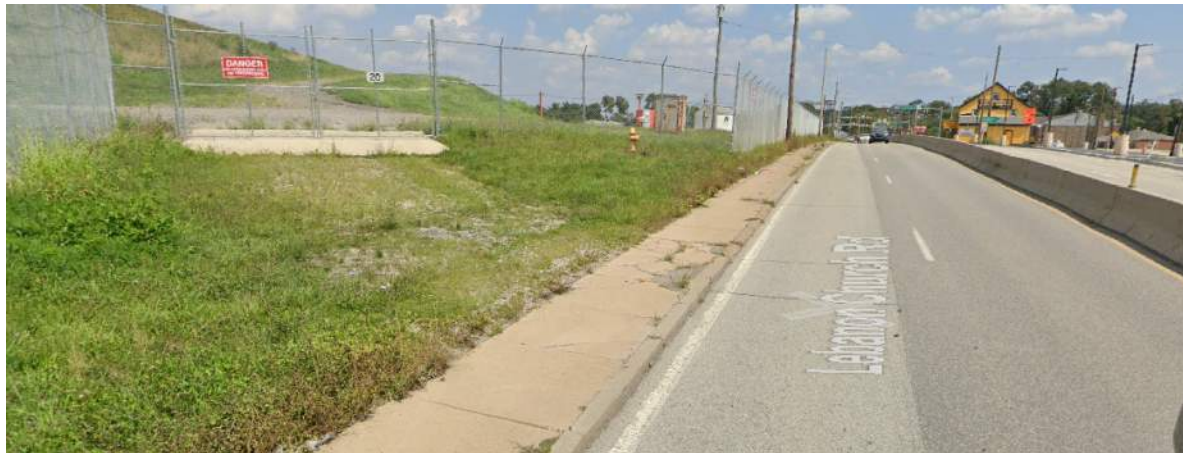
Construction vehicles could use the existing gated driveway to reach the midfield and east end of Runway 28, which connects with SR 2040 (Lebanon Church Rd) opposite the western intersection with Rodeo Dr. SR 2040 (Lebanon Church Rd) has a median barrier, so this driveway would only serve exiting vehicles turning right.

Existing Airfield Driveway Location Opposite Rodeo Drive West

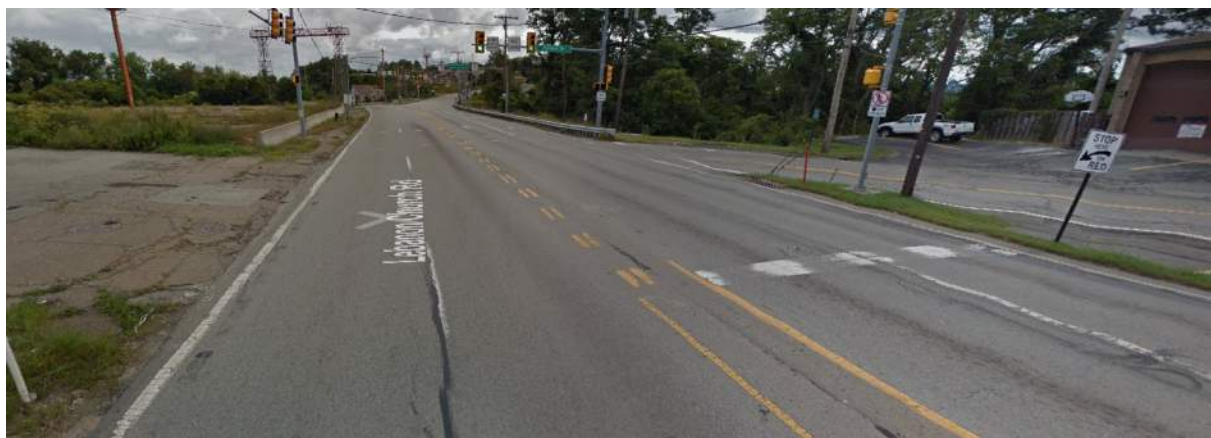
Construction vehicles could use the existing gated driveway to reach the midfield and east end of Runway 28, which connects with SR 2040 (Lebanon Church Rd) opposite the eastern intersection with Rodeo Dr. This intersection is signalized, and Rodeo Dr (County Rd) connects residential roads and operates as a jughandle, since SR 2040 (Lebanon Church Rd) has a median barrier. There are no signal heads facing the existing driveway.

Existing Driveway Location Opposite Rodeo Dr East

The existing driveway opposite Rodeo Drive East would be suitable for an entry-only driveway, paired with the curb cut 200 ft to the west or the driveway opposite Rodeo Drive West as an exit-only driveway. To convert this driveway to full access, modification to the existing signalized intersection would be required, including adding signal heads on the driveway approach. Refer to Figure 6 for a summary of the existing and recommended driveway locations.

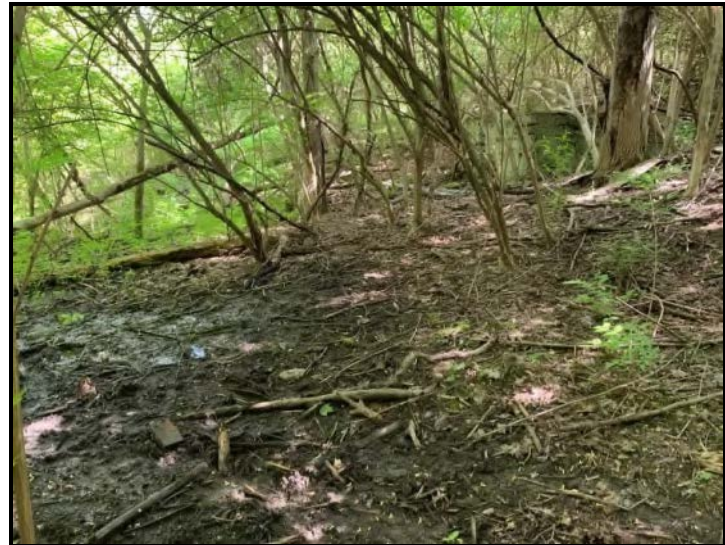
4) 05/21/2021: AGC Airfield west of runway 10, facing north Looking at the edge of Wetland 1. Ground was saturated and contained shallow stagnant pools.

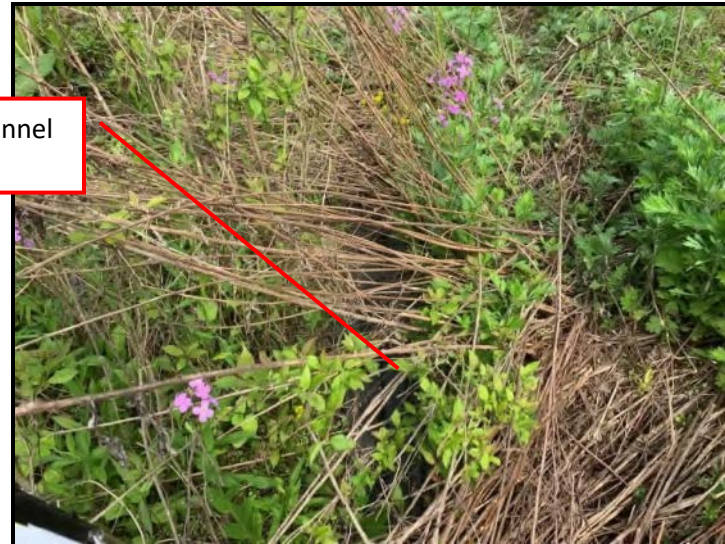
Geo lining in channel bed

8) 05/20/2021: AGC Airport west of runway 10, looking at the geo lining along the bed in Channel 2.

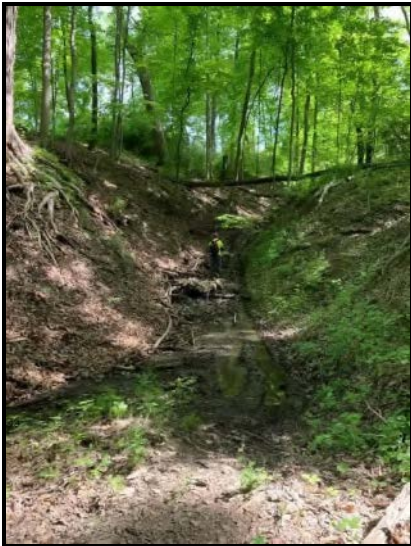
11) 05/20/2021: AGC Airport west of runway 10, facing northwest and upstream in Channel 4.

Channel 4, designated as CH-4, is a natural perennial stream channel that flows southwest and intersects with Channel 3 at the bottom of the hillslope outside of the study area, as shown on Figure 5. (Photographs 11-13). It is an unnamed tributary that eventually flows to Streets Run and the Monongahela River. Multiple channels were observed flowing into Channel 4 including Channel 5, Channel 6, Channel 7, and Channel 8. At the representative sampling location, the channel is approximately ten feet wide from bank to bank with a channel depth of four feet. The substrate is mainly comprised of bedrock and clay with gravel and silt. The channel flow was low to moderate with shallow slopes, and minimal erosion on both sides of the bank with fallen trees throughout. At the time of observation, the flow width was approximately three inches with a flow depth of one to two inches. Scuds were the only macroinvertebrates observed in the channel at the time of the site visit. The contributing hydrology to this channel is groundwater seep and surrounding surface water, which also contributes to WET-1 (Photograph 14). The approximate location of Channel 4 is shown on Figure 5. A Habitat Assessment Field Data Sheet form was completed for the observed reach of Channel 4. Channel 4 received a total score of 110.

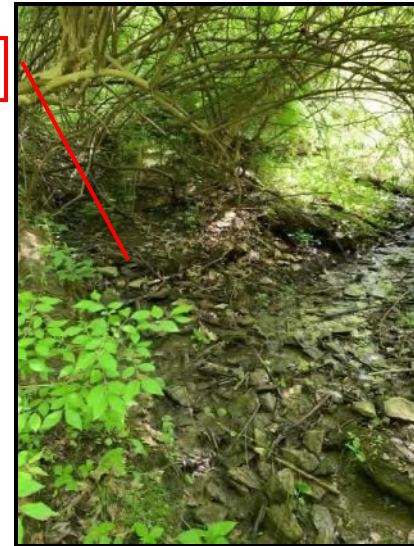
12) 05/20/2021: AGC Airport west of runway 10, facing north and upstream in Channel 4. Tributary to Channel 8 on the right bank.

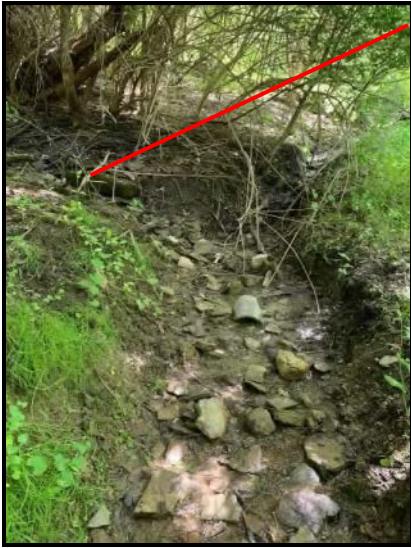
13) 05/20/2021: AGC Airport west of runway 10, facing north and upstream in Channel 4. Channel 6 intersects off the left bank.

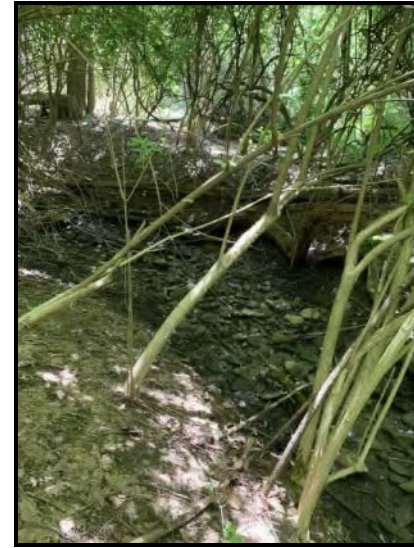
14) 05/20/2021: AGC Airport west of runway 10, facing south and downstream, where channel 4 begins. Channel 4 seems to flow from a groundwater seep.

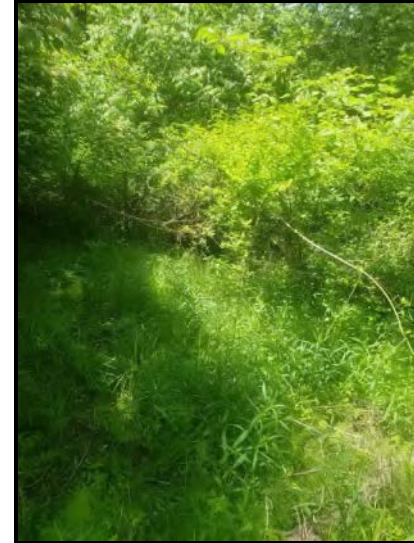
16) 05/20/2021: AGC Airport west of runway 10, facing southwest and downstream in channel 5. Channel 5 flows through Wetland-1.

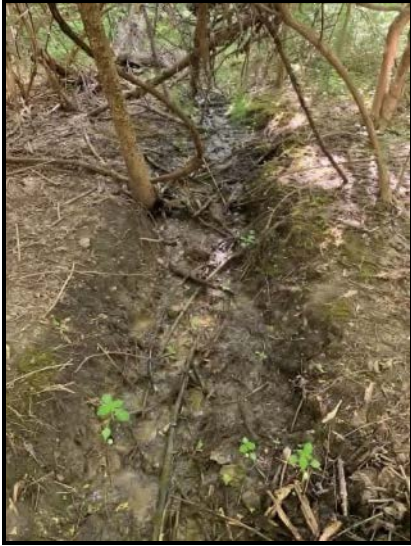
17) 05/20/2021: AGC Airport west of runway 10, facing north east and upstream in Channel 6. Ground was saturated but there was no flowing water.

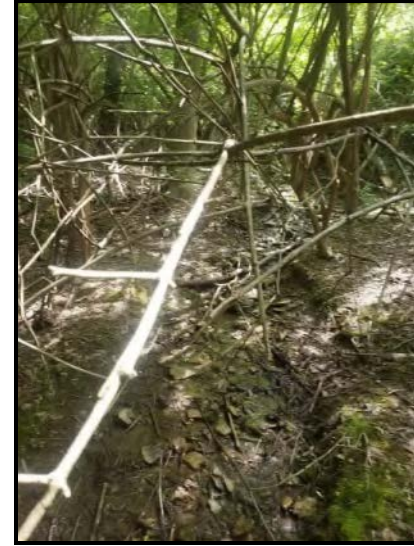
18) 05/20/2021: AGC Airport west of runway 10, facing south west and downstream in Channel 6. Ground contained puddles of stagnant water towards upstream end.

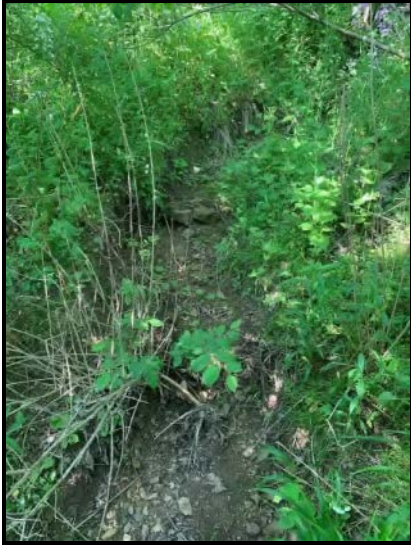
25) 05/25/2021: AGC Airfield north of runway 28, facing east and downstream in Channel 10. Channel 10 begins at Outfall 13.

Channel 10, designated as CH-10, is a man-made OSW channel located in the woods north of runway 10-28 and within the northern portion of the north study area of the airport property. (Photograph 25-26). The approximate location of Channel 10 is shown on Figure 6. The channel flow direction runs northeast when flowing and flows into Channel 11. The source of hydrology is from stormwater Outfall-13, located at the most upstream point of the channel. Due to thick vegetation, two sampling reaches were observed for Channel 10, one being upstream and one downstream. Field investigators were able to confirm that the channel flowing into Channel-11 was a continuation of the channel previously designated as Channel 10. The channel was dry at the time of observation. The stream channel was approximately three feet wide from bank to bank with a channel depth of three feet in the upstream sampling reach. The stream channel was approximately four feet wide from bank to bank with a channel depth of two feet in the upstream sampling reach. The substrate consisted mostly of silt, sand, and gravel throughout. Macroinvertebrates were not observed in the substrate. Channel 10 was characterized with having a deeply eroded down hillslope with thick vegetation covering the channel, and rip rap at the start of the channel. A Habitat Assessment Field Data Sheet form was completed for both observed reaches of Channel 10. The upstream reach of Channel 10 received a total score of 99 and the downstream reach of the channel received a total score of 85.

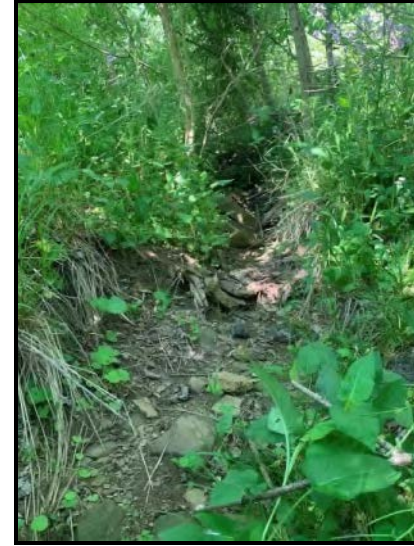
26) 05/25/2021: AGC Airfield north of runway 28, facing west and upstream in Channel 10. Channel 10 did not contain flowing water.

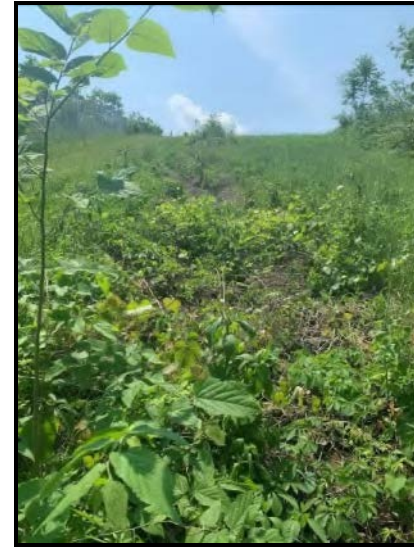
30) 05/25/2021: AGC Airfield east of runway 28, facing south and upstream of Channel 12. Channel 12 begins at Outfall 19.

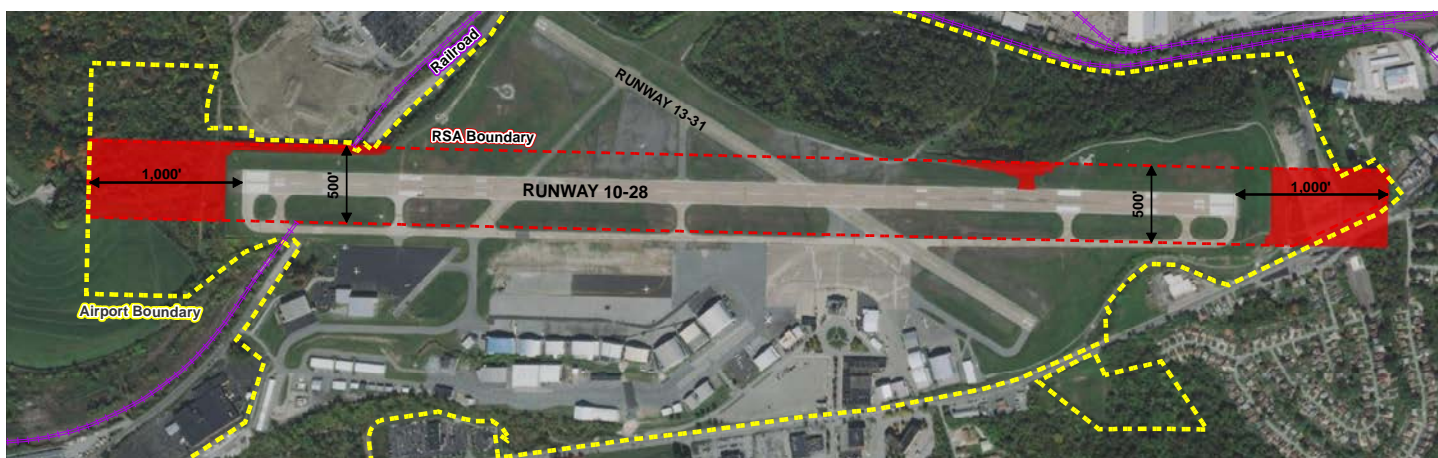
Current standard RSA deficits for Runway 10-28 are highlighted in red.

At this time, we are studying potential combinations of solutions, such as placing fill material (clean dirt or stone) in some areas along the RSA on airport property and at both ends of the Runway 10-28. To correct the slope at this end, we may install a retaining wall or extend the fill over the landfill. We are also considering the installation of an Engineered Material Arresting System (EMAS) at both ends of the runway.
